Title: Critical Lands - representative sample area in south west section of the watershed 2008/9			
Project: <i>Rehabilitation of Tondano Lake Area Project</i>			
Map No.: 06	Approx. Scale: 1 : 6 000	Data Source: Topographic Mapping, Bakosurtanal, Kimpraswil and PRPG	Produced: Mott MacDonald Praha, s.r.o.
Compiled: Dr. Karel Peter Kucera		Digitized/Operator: Petr Hladik

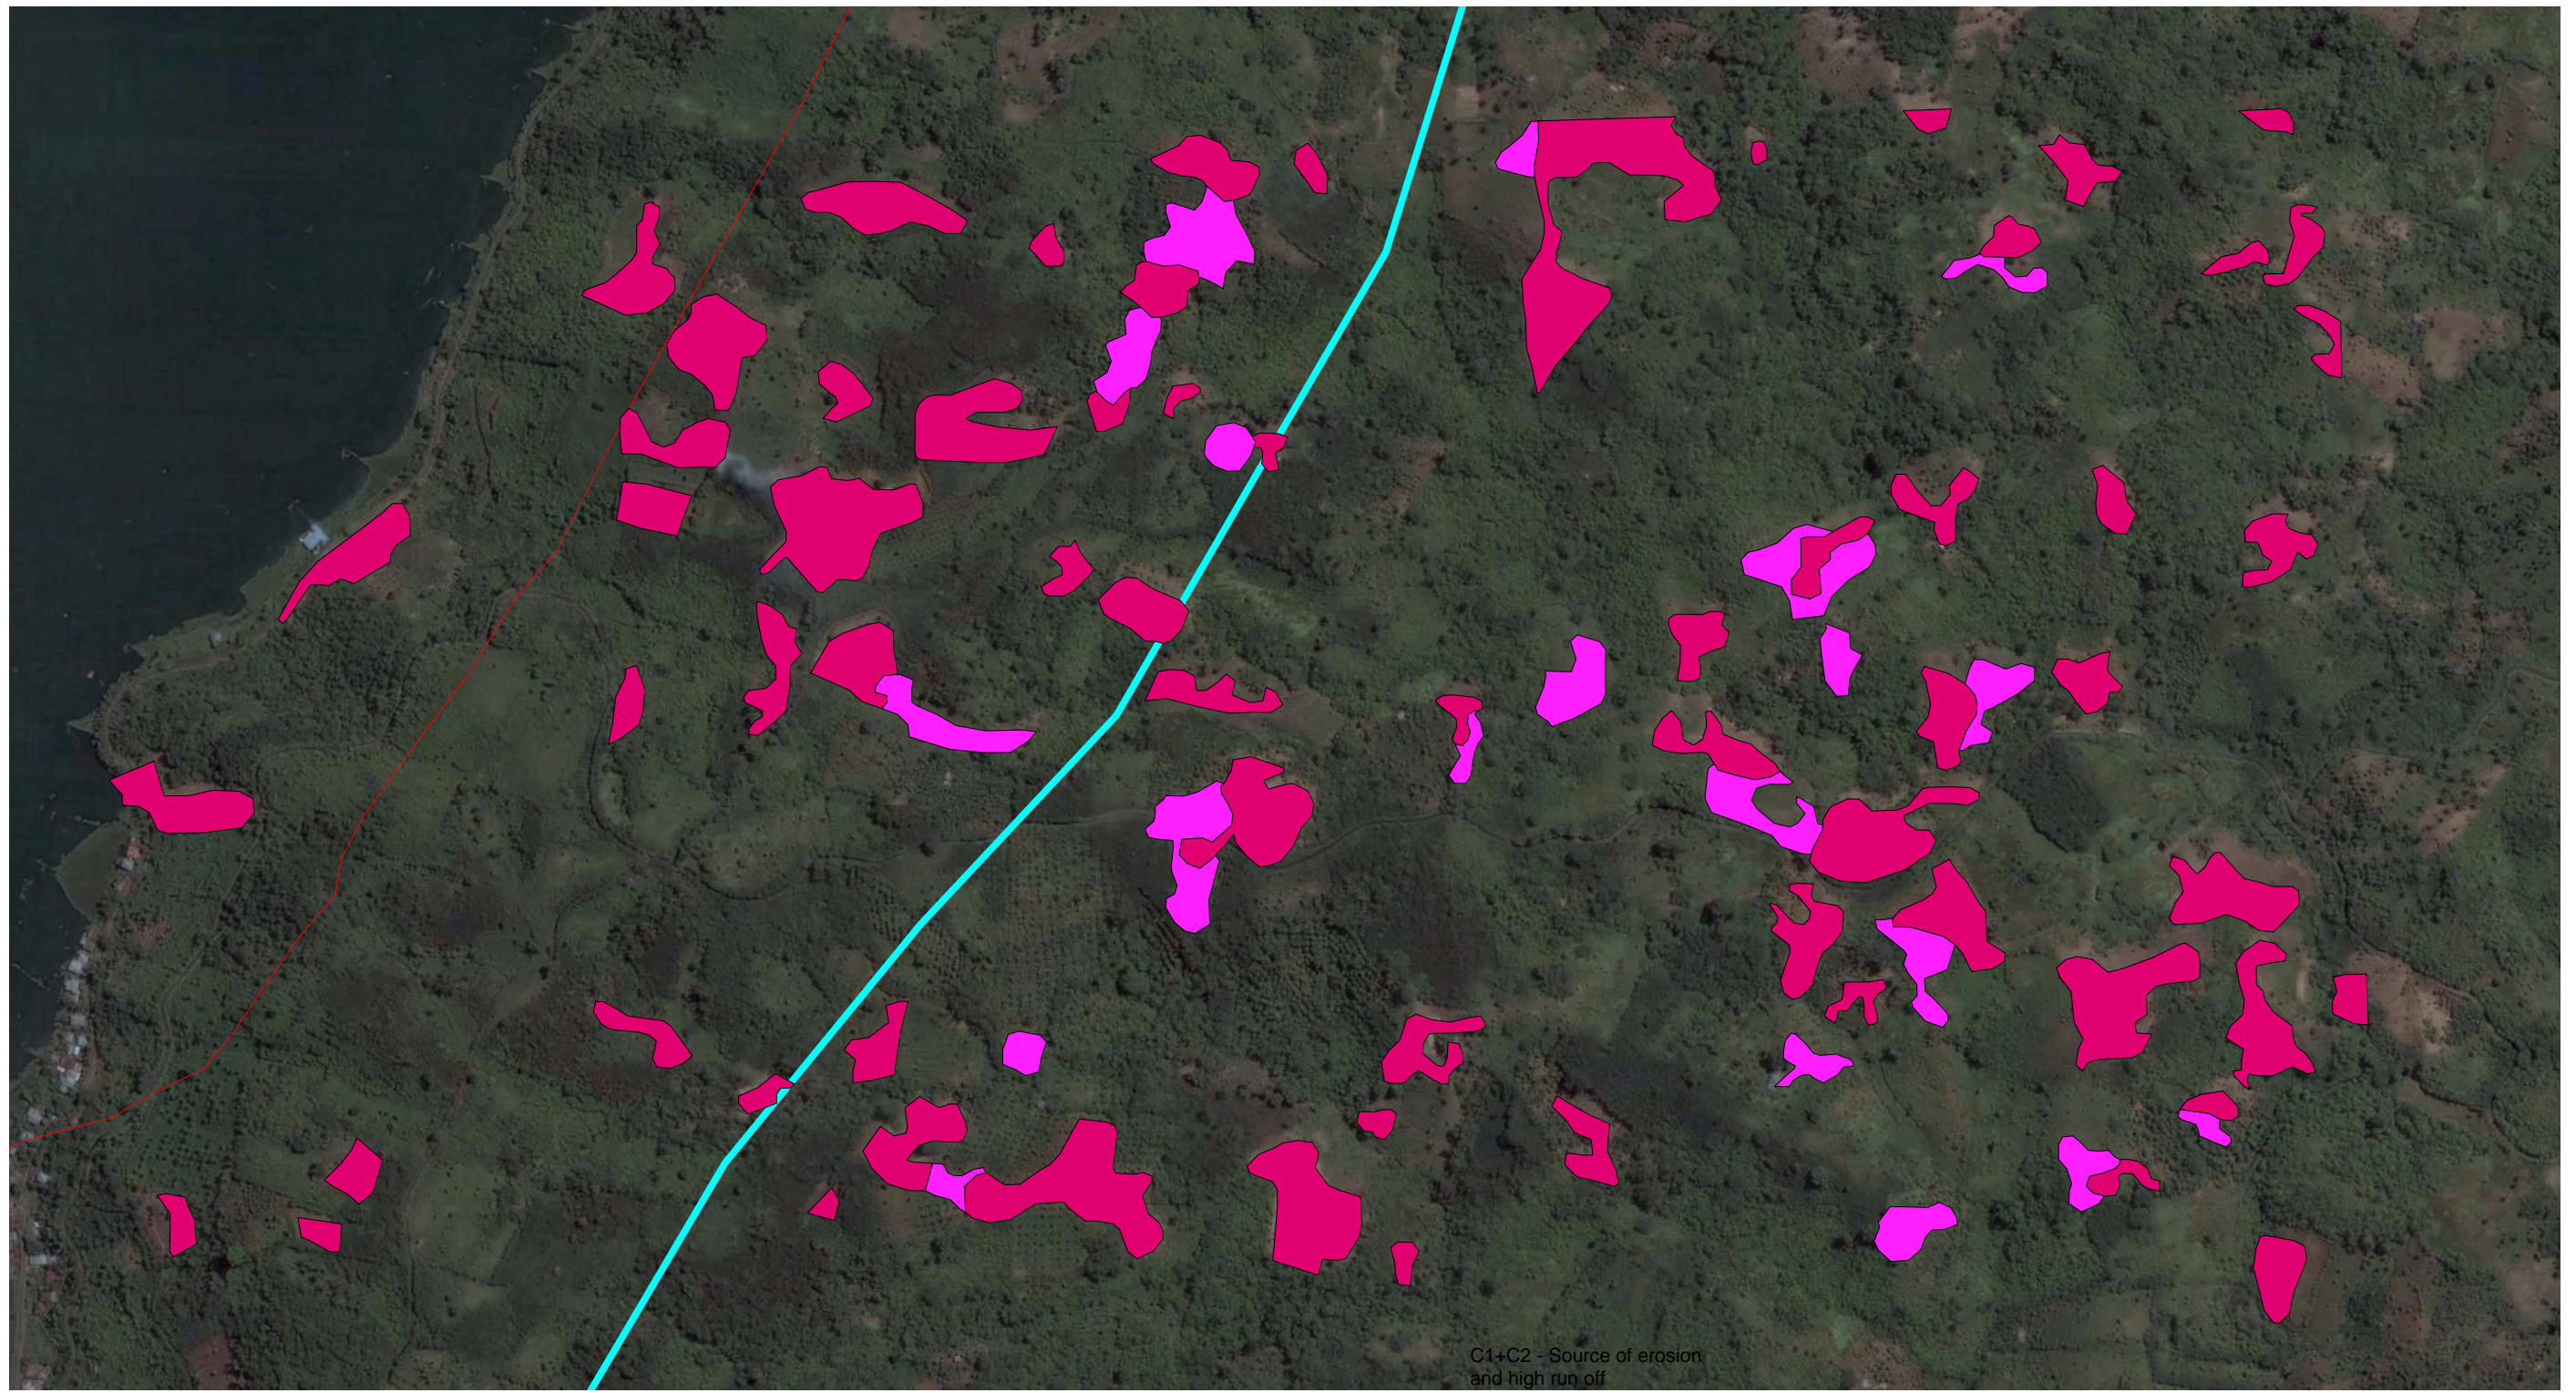
C1+C2 - Source of erosion and high run off

- C1 Very Critical Land - poor or no vegetative cover with 50 to 80 percents degraded / bare land. Major source of erosion.
- C2 Critical Land - poor or no vegetative cover 20 -49 percents degraded bare land in dry season. Significant source of erosion.
